PROJECT NAME
Molonglo Valley Interceptor
Sewer

REFERENCE NO.
26-WAS-ACT001-001

**PUSHING NEW FRONTIERS FOR
CANBERRA SEWER**

Innovative sewerage rehabilitation to cater for future pressure.

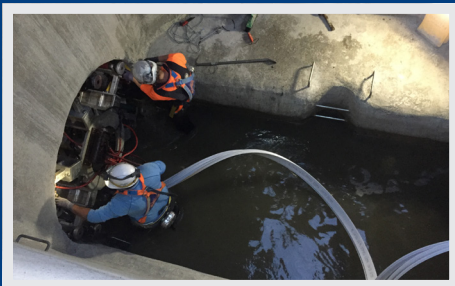
Setting up the Rotaloc winding machine

Interflow then adapted its methodology so the project could be carried out without disrupting the sewer, and staff drew on their technical expertise and innovation to stabilise and modify the SPR™ RO - Rotaloc winding machine in order to complete the installation.

Interflow cleaned the inside of the sewer using high-pressure cleaning and then used the Australian-developed Rib Loc SPR™ RO - Rotaloc PVC spiral wound lining system to rehabilitate it. This system uses a SPR™ RO - Rotaloc winding machine to traverse along the inside of the pipeline, spirally winding a ribbed strip of uPVC, locking the edges together to form a pipe-within-a-pipe. It was necessary to stabilise the machine and carry out reconfigurations so it would work in the pipe's large diameter – almost two metres – and in the high-flow conditions. Getting it in to the sewer relied on it being disassembled and then passed down through the top of the manhole and reassembled once inside.
