**Interflow**<sup>®</sup>

**PROJECT NAME**  
Sewer Relining

**LOCATION**  
View Street, Bendigo VIC

## SEWER RELINING WORKS IN SENSITIVE CONDITIONS

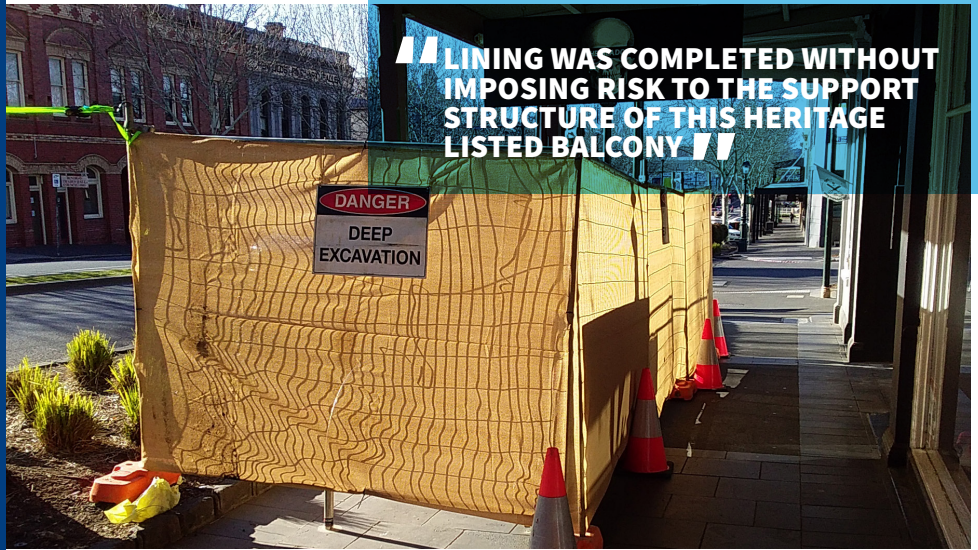
*The liner being wound through broken sections and joined with PVC couplers*

A structural SPR™ EX - Expanda spiral wound liner was used to renew the full length of the sewer in these two sections, and joined in the middle via PVC pipework and couplers. Interflow used stabilised sand for backfill material to ensure there would be no subsidence post-completion of works, which could risk damage to the balcony and settlement of the asphalt reinstatement.
