Maylands Branch Sewer Refurbishment

22-WAS-WAT001-040

MULTI-SKILLS NEEDED FOR PERTH SEWER REHABILITATION PROJECT

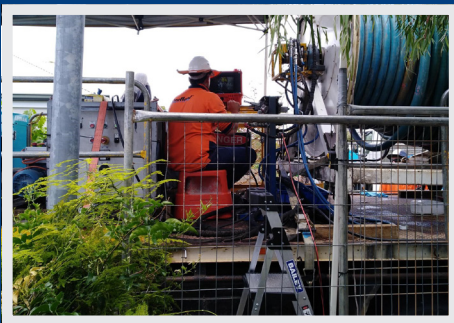
Rotaloc machine operator lining the pipe by remotely controlling the machine.

Rotaloc is installed from existing access points, with the machine removed from the sewer at the end of each shift. On this project the small shafts wouldn't allow this access, so the winding machine remained in the sewer while the full 1.2-kilometre length was lined. A special control system was developed for remote machine operation and control from above ground, using wireless communication with routers and fibre optics.
